**DEPARTMENT OF TRANSPORTATION****DIVISION OF ENGINEERING SERVICES**

Contract #: 04-0120F4Cty: SF/ALA Rte: 80 PM: 13.2/13.9File #: 69.28**WELDING INSPECTION REPORT****Resident Engineer:** Pursell, Gary**Address:** 333 Burma Road**City:** Oakland, CA 94607**Report No:** WIR-002536**Date Inspected:** 20-May-2008**Project Name:** SAS Superstructure**OSM Arrival Time:** 630**Prime Contractor:** American Bridge/Fluor Enterprises, a JV**OSM Departure Time:** 1530**Contractor:** Zhenhua Port Machinery Company, Ltd (ZPMC), Changxing Island **Location:** Shanghai, China

## WELDING INSPECTION REPORT

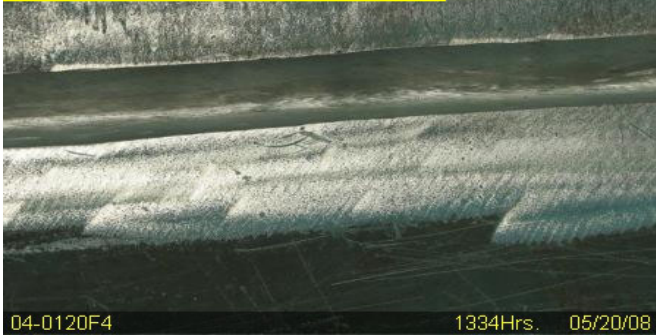
This QA also observed various related welding activities ranging from grinding/cleaning of other side of groove bevel after carbon arcing on diaphragm plate WD1-A1-B-1B, preheating of diaphragm plate WSD1-SA226-10A

Bay #8: Tower Diaphragms  
WD1-A1-B-1B Diaphragm plate ground  
to sound metal after carbon arcing.

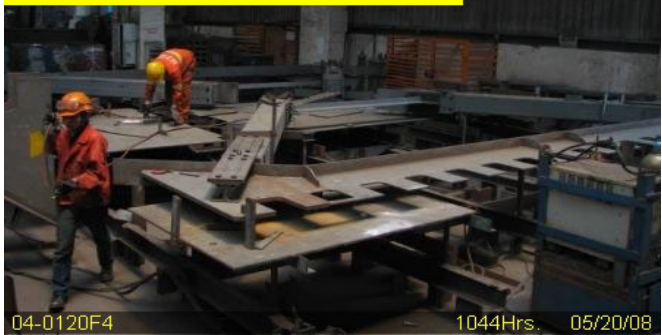
Bay #7: OBG Floor Beams.  
Sub-assembly of floor beam to 300mm X  
300mm hollow steel underway.
